# Manhole Inspection Summary

Manhole # S19MM\_015MH

**Location** Address: **BEHIND 2324 MONROE ST**

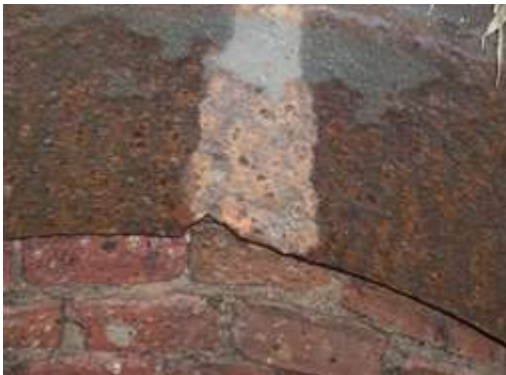
Comments **frame is worn**

worn frame

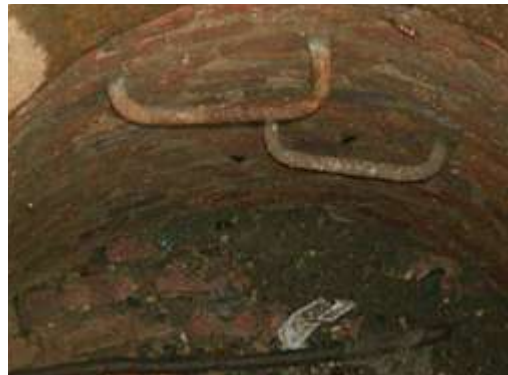
Defect 1

**Steps** Count: **2** Missing: **0** ☒ **Corroded**

CORRODED STEPS

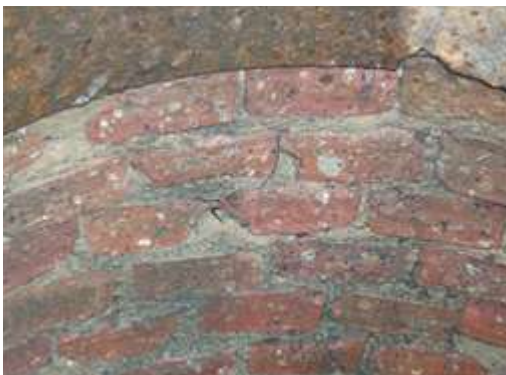
Defect 2

Condition: ☐ Sound ☐ Cracked ☐ Root Intrusion ☐ Loose Brick ☒ **Deteriorated**

DETERIORATION OF CORBEL

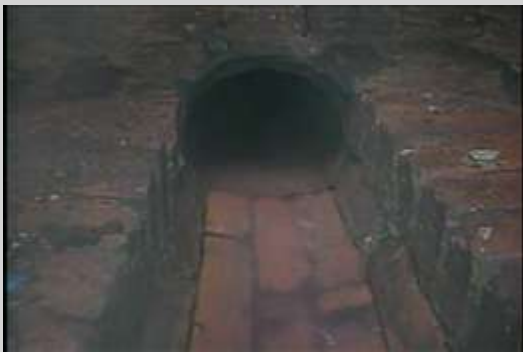
12 O'Clock Outflow

8 in. Circular Gravity Sewer  
Pipe Out @ 12 O'Clock

Pipe Height: **8.4** (in.) Rod and Bar (Angled)  
Pipe Material: **Clay** ☐ Pipe Lined  
Invert Depth: **6.01** (ft.) Flow Characteristics: **Slow**  
Deposits: ☒ None ☐ Mud ☐ Sludge ☐ Debris ☐ Grease  
Silt Depth: (in.) Deposits Extent:  
Infiltration: **None** Pipe Seal Cond: **Sound**

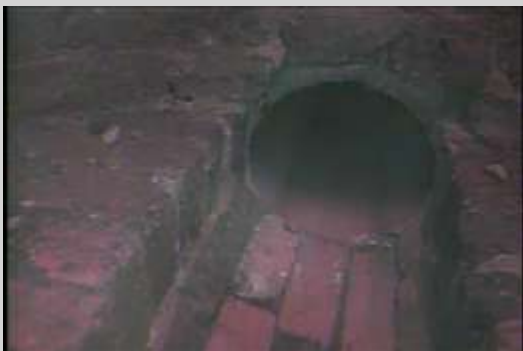
8 O'Clock Inflow

8 in. Circular Gravity Sewer  
Pipe In @ 8 O'Clock

Pipe Height: **8.4** (in.) Rod and Bar (Angled)  
Pipe Material: **Clay** ☐ Pipe Lined  
Invert Depth: **5.91** (ft.) Flow Characteristics: **Slow**  
Deposits: ☒ None ☐ Mud ☐ Sludge ☐ Debris ☐ Grease  
Silt Depth: (in.) Deposits Extent:  
Infiltration: **None** Pipe Seal Cond: **Sound**
